EXPERIMENTAL STUDY OF THE COATING FORMED ON NITRIDED-STEEL

PISTON RINGS DURING OPERATION IN NITRIDED-STEEL CYLINDERS

By A. R. Bobrowsky, J. Howard Kittel, and Charles P. Boegli

Aircraft Engine Research Laboratory Cleveland, Ohio

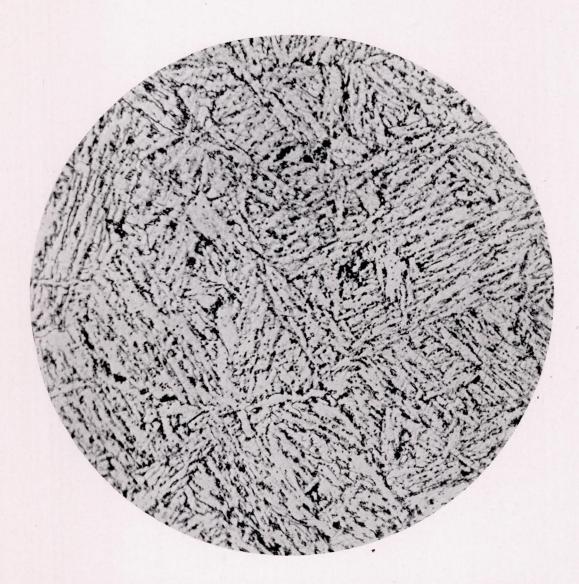
Figure 3.—Core structure of a typical nitrided-steel piston ring. Etched in nital. \times 1,500.

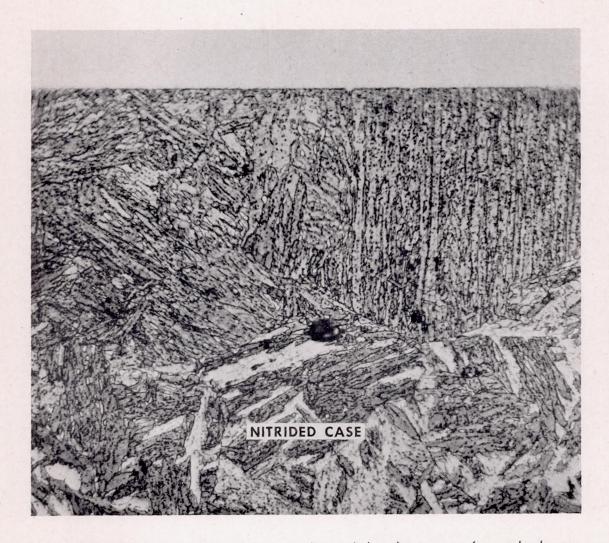
Figure 4.—Transverse section of the running face of a nitrided-steel piston ring after test that has not developed coating material. The grain structure is undeformed up to the surface of the ring. This undeformed material is characteristic of those areas where coating material has not been formed. Etched in nital. ×1,500.

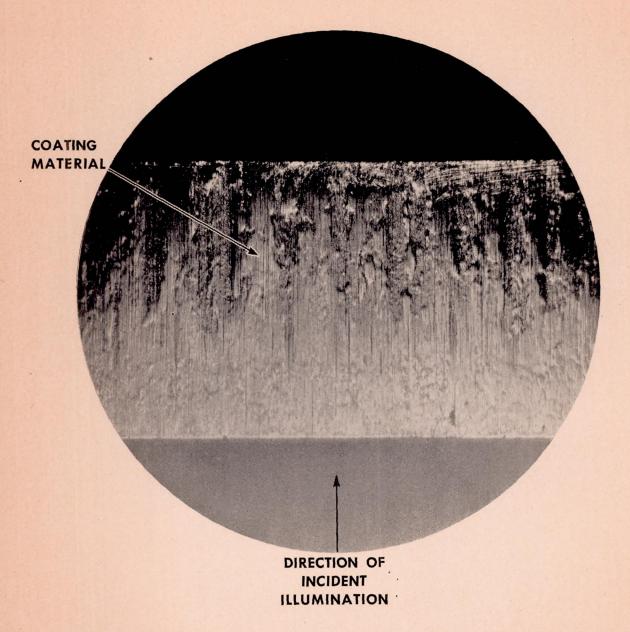
Observations of nitrided rings after operation indicated that the coating in a piston-ring face may occur in a mottled condition (fig. 7) or a relatively continuous condition (fig. 8). Inspection of many piston rings indicates that the rings which have operated the longest periods show a more nearly continuous appearance of coating than the rings which have operated for shorter periods. The running surface of the barrel appears to contain only small amounts of the coating. (See fig. 9.)

Figure 7.—Running face of a nitrided-steel piston ring after test, showing mottled occurrence of highly reflective material. Oblique illumination. Because the bright side of each area faces the light source, it is apparent that the coating material is elevated above the nominal surface. Same ring as figure 2. Unetched. ×45.

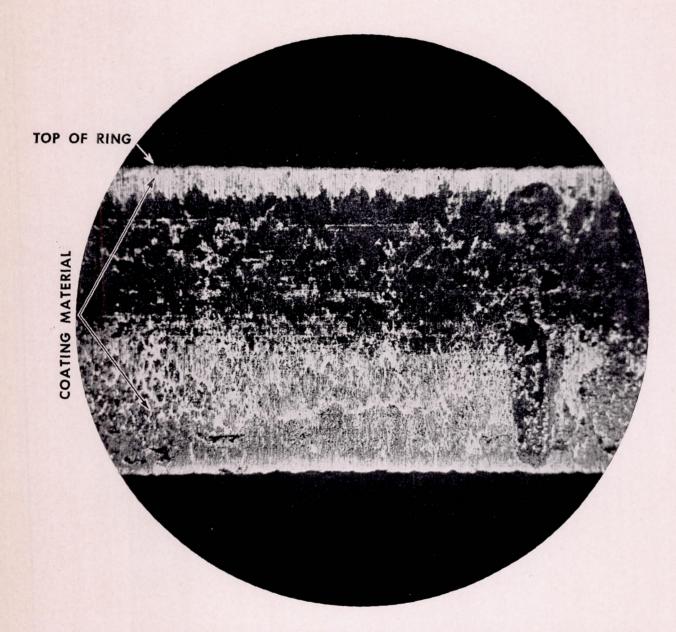
Figure 8.—Running face of a nitrided-steel piston ring after test, showing continuous occurrence of highly reflective material. Vertical illumination. This ring ran for 25 hours at 2,500 r. p. m. and a brake mean effective pressure of 209 pounds per square inch. Etched with dilute nitric acid. \times 50.
